Contract #: 04-0120F4Cty: SF/ALA Rte: 80 PM: 13.2/13.9File #: 69.28**WELDING INSPECTION REPORT****Resident Engineer:**Pursell, Gary**Address:** 333 Burma Road**City:** Oakland, CA 94607**Report No:** WIR-014753**Date Inspected:** 11-Jun-2010**Project Name:** SAS Superstructure**OSM Arrival Time:** 700**Prime Contractor:** American Bridge/Fluor Enterprises, a JV**OSM Departure Time:** 1900**Contractor:** Zhenhua Port Machinery Company, Ltd (ZPMC), Changxing Island **Location:** Shanghai, China

Bridge No: 34-0006**Component:** Tower Components**Summary of Items Observed:**

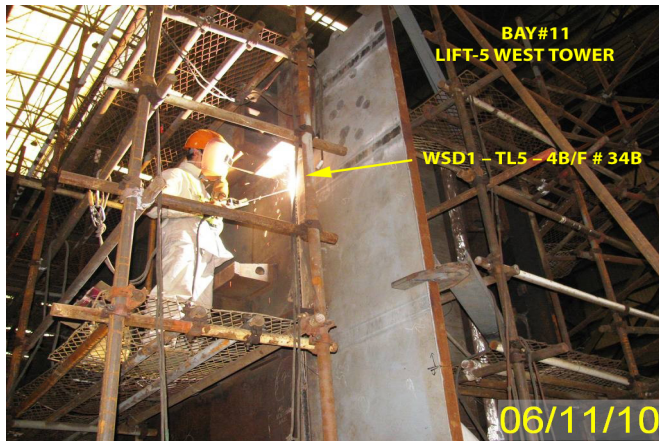
Weld joint # 34B located on Lift – 5 west tower A/E corner to Grillage plate WSD1 – TL5 – 4B/F. Welder is identified as 049704. ZPMC Quality Control (QC) Inspector is identified as Xu Jin Long. The welding variables recorded by QC appeared to comply with the WPS – B – T – 3213 – B – U3b.

(See attached photo)
